Subject: Wetland Investigation Summary Letter

Riveredge Industrial Park

150 Lukens Drive New Castle, DE 19720 Tax Parcel: 21-022.00-002

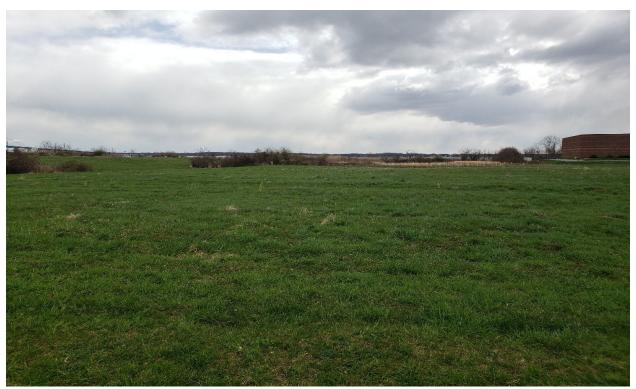
Photo 1: Mowed field area in the southern portion of the property, facing east.

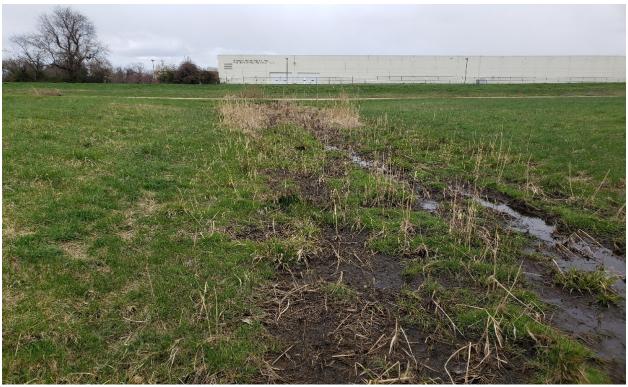
Photo 2: Stormwater drainage swale from Lukens Drive in the southern portion of the property, facing west.

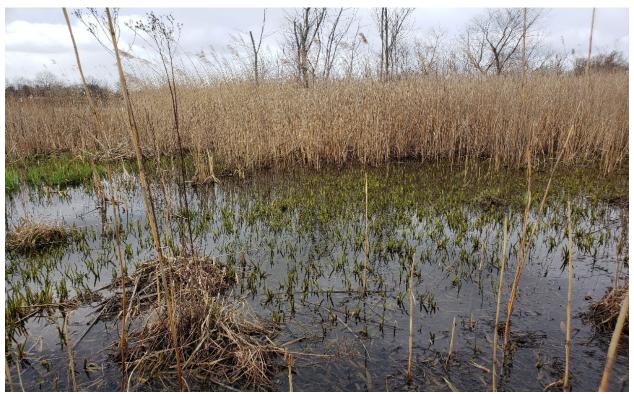
Photo 3: Tidal emergent wetland in the southeastern portion of the property, facing south.

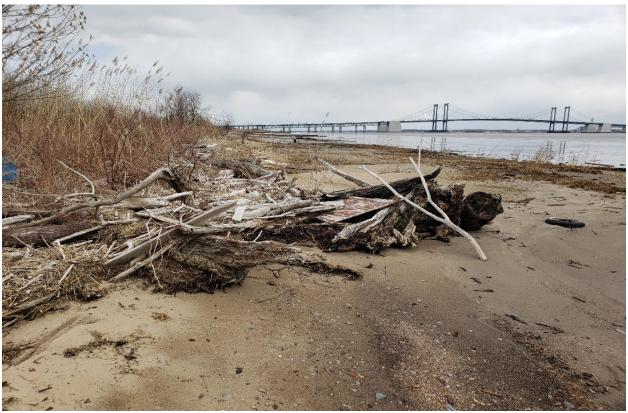
Photo 4: Tidal water boundary along the eastern property boundary, facing northeast.

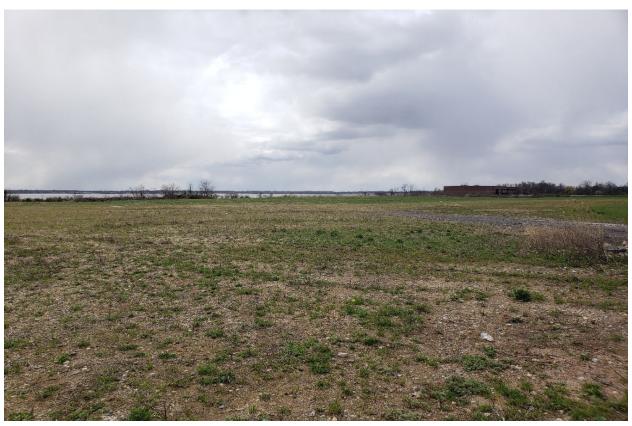
Photo 5: Mowed field area in the central portion of the property, facing southeast.

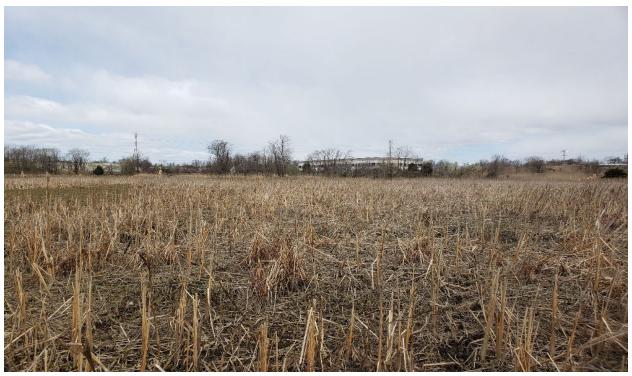
Photo 6: Tidal emergent wetlands in the north-central portion of the property, facing north.

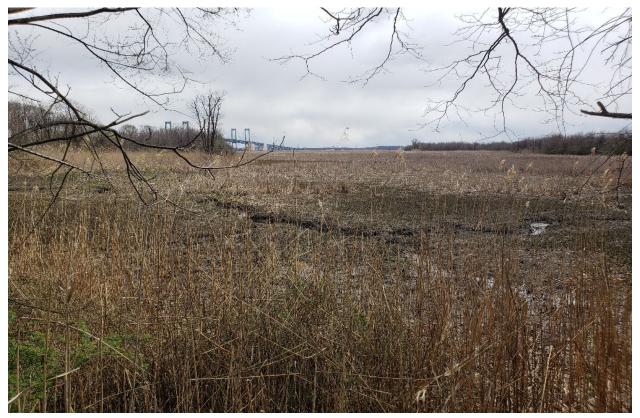
Photo 7: Tidal wetlands in the northwestern portion of the property, facing east.

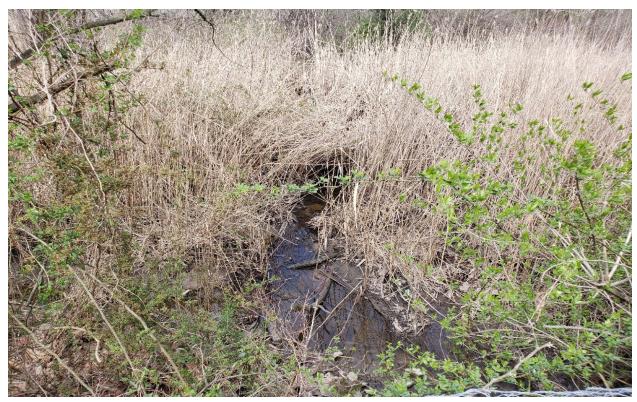
Photo 8: Emergent wetland area abutting railroad line along the northwestern property boundary, facing west.
