# RESEARCH GUIDE FOR NEW CASTLE PROPERTY OWNERS

# ADDITIONS and NEW CONSTRUCTION

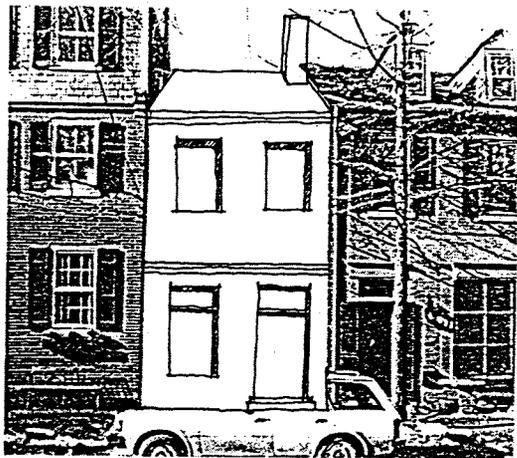
One of the most effective ways to evaluate designs for new construction is to superimpose a rendering of the proposed work on a photograph of the site. This allows the Historic Area Commission the opportunity to analyze both the new construction and its impact on the Historic Area. Above is a conceptual infill design which shows door and window openings, cornice line, roof slope, and placement of chimneys and other details, as well as the relationship of the proposed design to the adjacent structures.

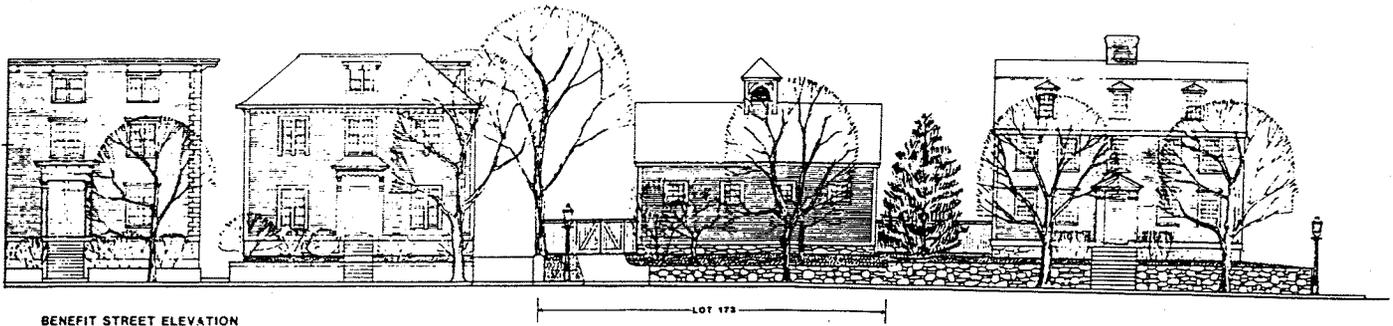
*A detailed scale drawing of a proposed antique car storage barn within the context of neighborhood buildings illustrates how it will relate to the residential character of Benefit Street in Providence, Rhode Island. (Kate Palmer Associates, Architects & Planners, 1984)*

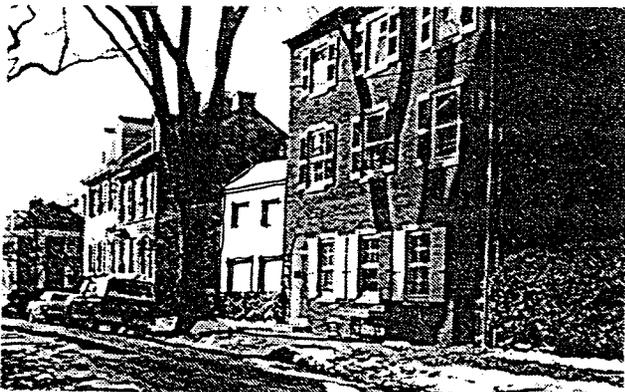
*Conceptual design for a new addition superimposed over a current streetscape photograph. This design shows the addition in context to its immediate neighbors and the streetscape. Often, placing a new addition on a secondary facade or setting it back from the property line will lessen the impact of the new work on the Historic Area.*

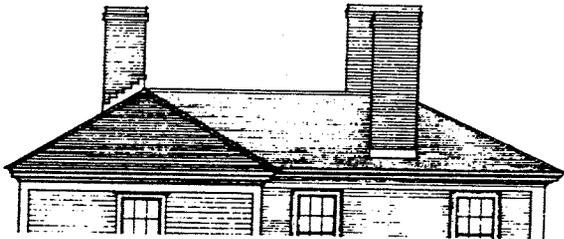
*Detail, tall Federal period interior end and center chimneys. John Nelson House. Lincoln, Massachusetts. 1811. (Courtesy of HABS)*

In general, there are three typical locations for chimneys: the center, interior end, and exterior end. An example of a center chimney in New Castle from the Georgian period is at the John Wiley House, 18 East Third Street. A Federal-style interior end chimney can be seen at the James Booth, Jr. House at 212 Delaware Street. There are few examples of exterior end chimneys in New Castle, which is surprising since this type of chimney is characteristic of the Tidewater region. An extant example is the so-called "Little House" at 24 East Third Street. Chimneys that were built on additions or outbuildings were typically smaller in scale and less

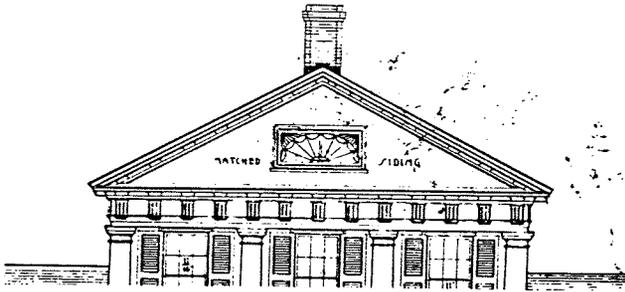
*Detail, Greek Revival chimney. Dr. John Matthews House. Painesville, Ohio. 1829. (Courtesy of HABS)*

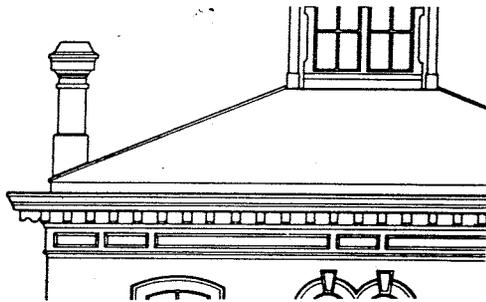
*Detail, high-style Italianate chimney. Albert Scott House. Petersburg, Virginia. c.1860. (Courtesy of HABS)*

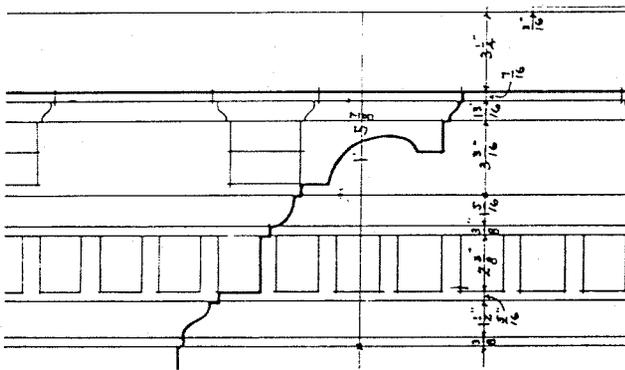
Detail, Georgian-style cornice with dentils and modillions. The Governor Smith House. Wiscasset, Maine. c.1780. Reprinted from the Architectural Treasures of Early America.

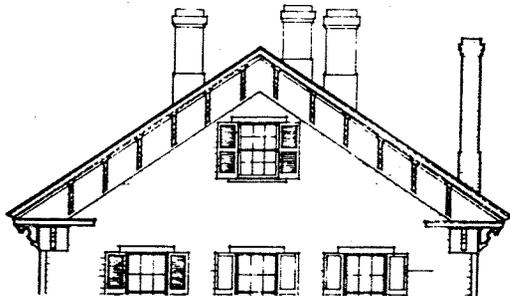
*Detail, Italianate-style wood cornice with prominent scrolled brackets. John Wentworth Farmhouse. Summit, Illinois. 1868. (Courtesy of HABS)*

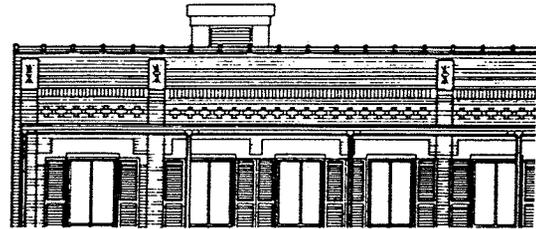
*Detail, High-style corbeled brick cornice. Goodman Building. Austin, Texas. 1893. (Courtesy of HABS)*

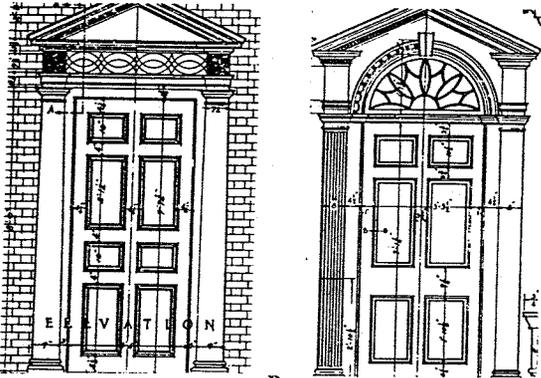
A. Detail, Georgian style entrance with pedimented frontispiece and 8 panel door. The Johns House. New Castle, Delaware. C. 1760. (Courtesy of HABS) B. Detail, Federal style entrance with broken pediment frontispiece, fanlight and 6 panel door. The Fisher House. Oley, Berks County, Pennsylvania. C. 1790. (Courtesy of HABS)

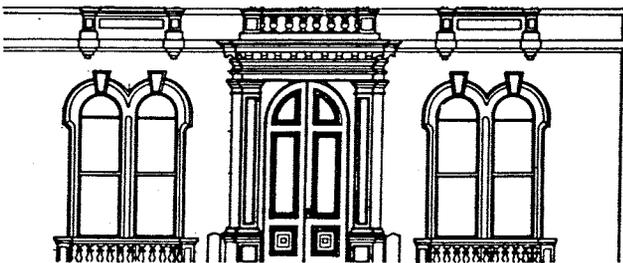
Detail, Italianate entrance with double leaf doors with molded panels and glazing and portico. Albert Scott House. Petersburg, Virginia. C. 1860. (Courtesy of HABS)

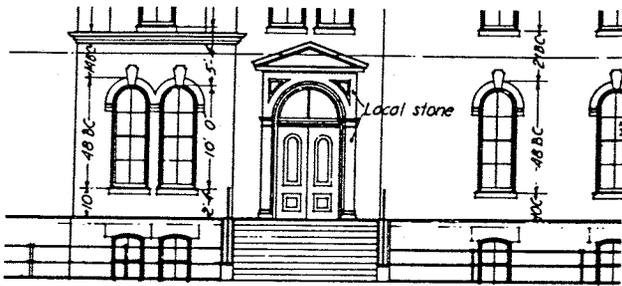
*Detail, Second Empire entrance with double leaf doors with round-headed panels. McKinley High School. Lincoln, Nebraska. 1872. (Courtesy of HABS)*

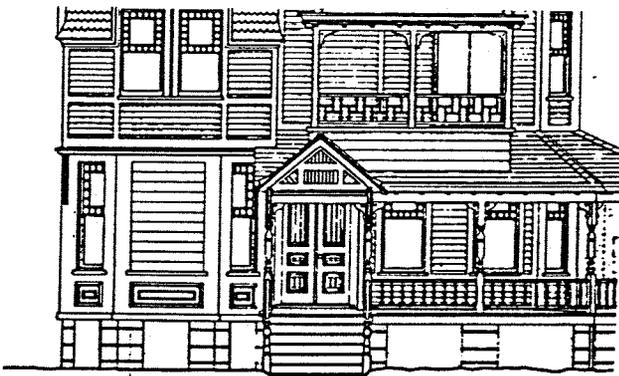
*Detail, Queen Anne entrance with double leaf ornamented, multiple-panel doors. Miss Parks House. Cape May, New Jersey. C. 1876. (Courtesy of HABS)*

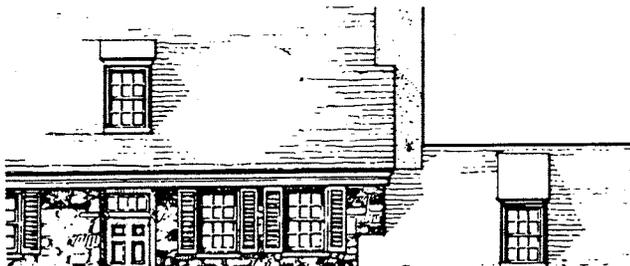
*Shed dormers. Glen Fern. Philadelphia, Pennsylvania. 1733-1739. (Courtesy of HABS)*

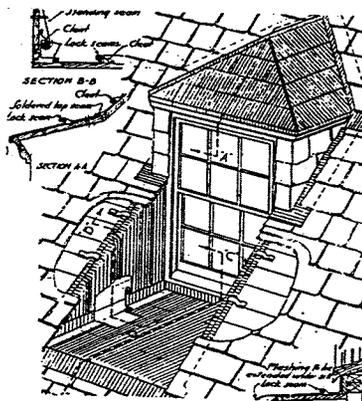
*Hipped dormer. Architectural Graphic Standards, Second Edition.*

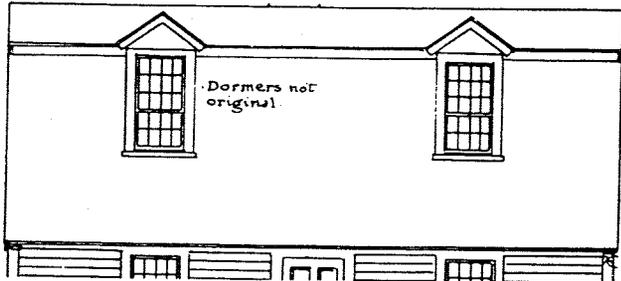
*Gabled dormers. Old Poole Cottage. Rockport, Cape Ann, Massachusetts. 1750-1760. Reprinted from The Architectural Treasures of Early America.*

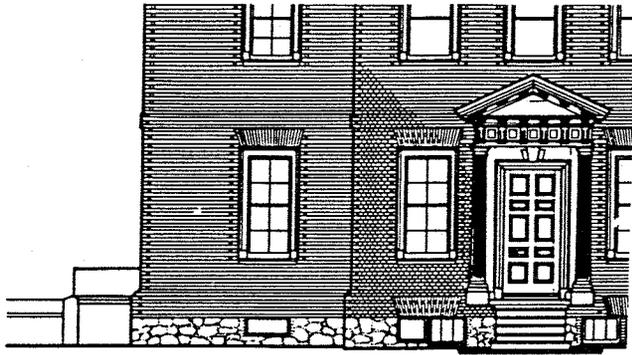
Georgian-style house with watertable and belt course. Dr. Upton Scott House. Annapolis, Maryland. 1762-1765. (Courtesy of HABS)

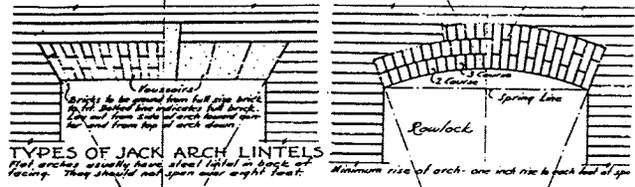
Flat and rowlock lintels. Reprinted from Architectural Graphic Standards, Second Edition.

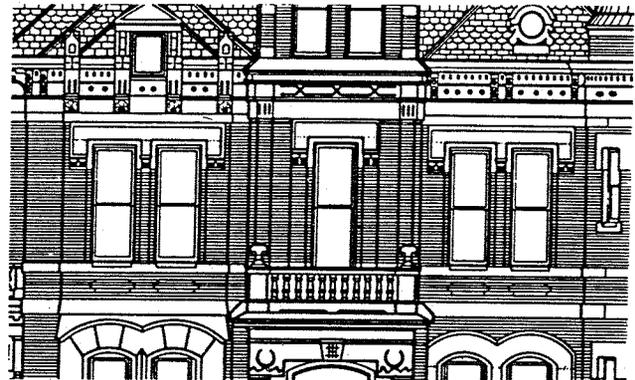
Bracketed window hoods. John Houghton House. Austin, Texas. 1886-1887. (Courtesy of HABS)

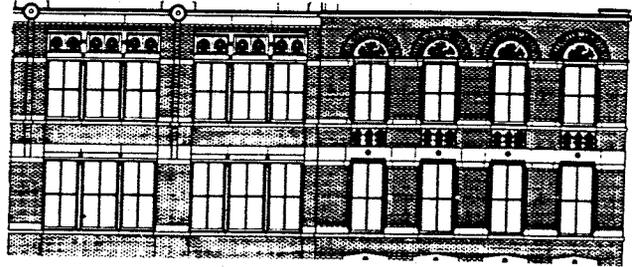
Polychromatic brickwork. Scoville Building. Chicago, Illinois. 1884. (Courtesy of HABS)

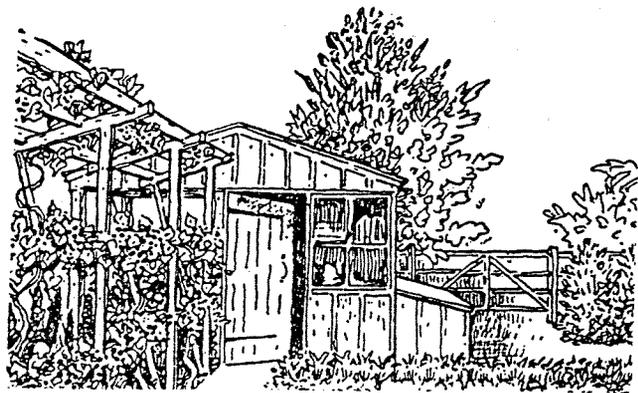
*Example of a simply designed tool house with board and batten siding, multiple-light sash, and vertical board door with strap hinges.*

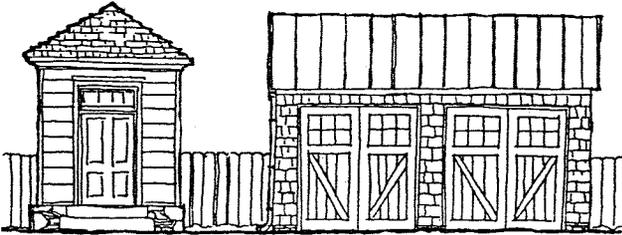
*Conceptual design showing (left) a mid-nineteenth-century shed and (right) a c. 1920 double garage, demonstrating compatibility of two different styles through massing, height, and similar materials, i.e., wood clapboard and shingles, hinged wood doors, masonry bases of brick and stone, and multiple-light glazing.*

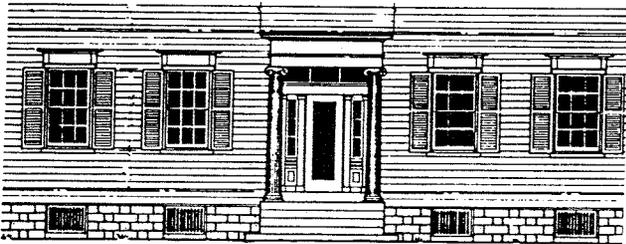
*Detail, Greek Revival style portico with Ionic columns. Isaac Crane House. Montclair, New Jersey. 1838 remodeling of 1795 dwelling. (Courtesy of HABS)*

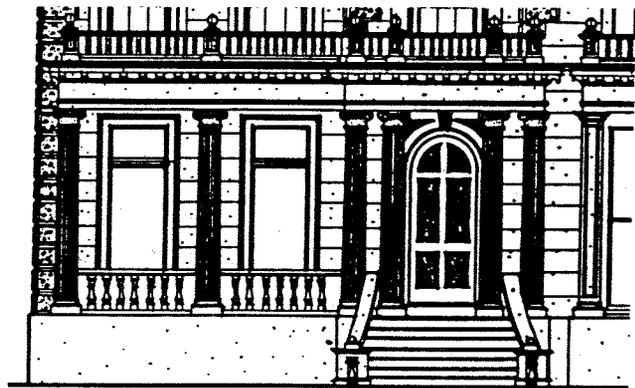
*Detail, high style Italianate porch with Ionic columns. Morse-Libby House. Portland, Maine. C. 1859. (Courtesy of HABS)*

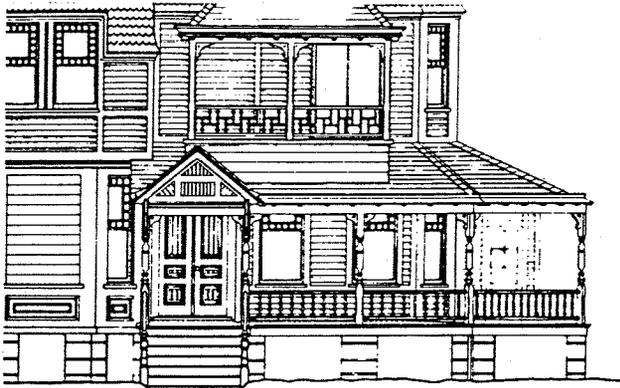
*Detail, Queen Anne-style veranda and second-floor porch with Japanese-style railing. Miss Parks House. Cape May, New Jersey. (Courtesy of HABS)*

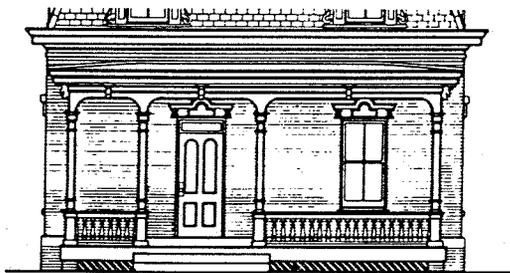
*Detail, Vernacular Second Empire-style porch. Captain's Cottage No. 2. Sailors' Snug Harbor, Staten Island, New York. 1885. (Courtesy of HABS)*

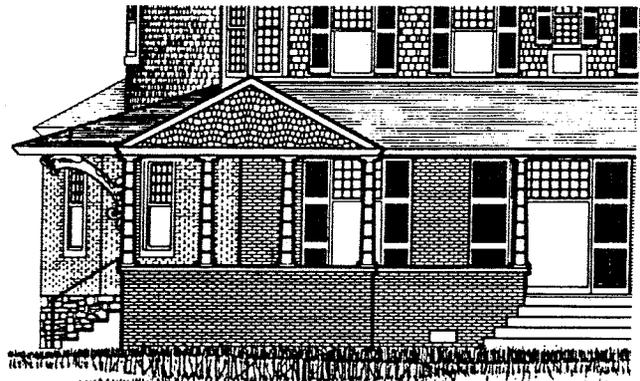
*Detail, Shingle-style veranda with tapered posts and shingles in porch gable. Isaac Bell House. Newport, Rhode Island. 1872. (Courtesy of HABS)*

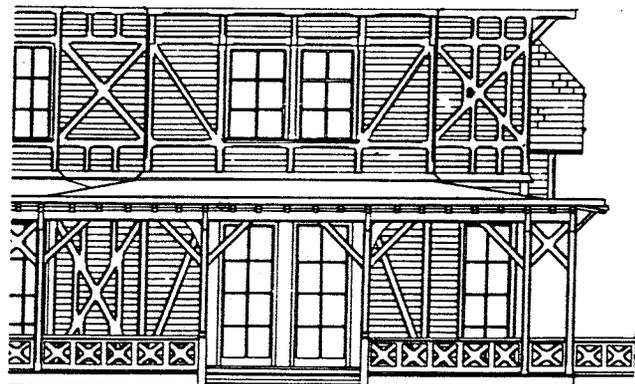
*Detail, Stick-style porch. John Griswold House. Newport, Rhode Island. 1863-1864. (Courtesy of HABS)*

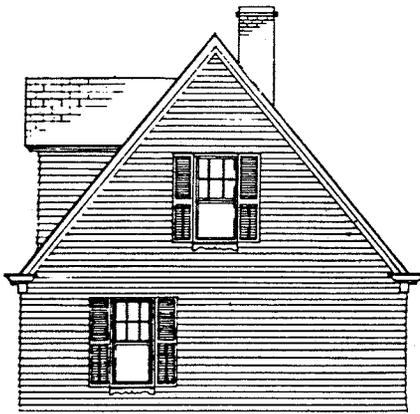
*Detail, Gable roof. President Kennedy birthplace. Brookline, Massachusetts. c. 1908. (Courtesy of HABS)*

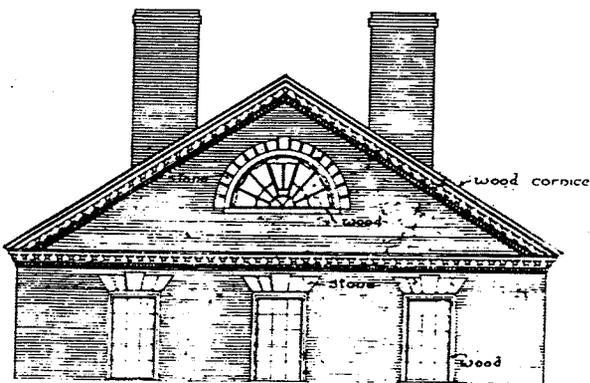
*Detail, Front end gable roof. Whittle House. Norfolk, Virginia. 1791. (Courtesy of HABS)*

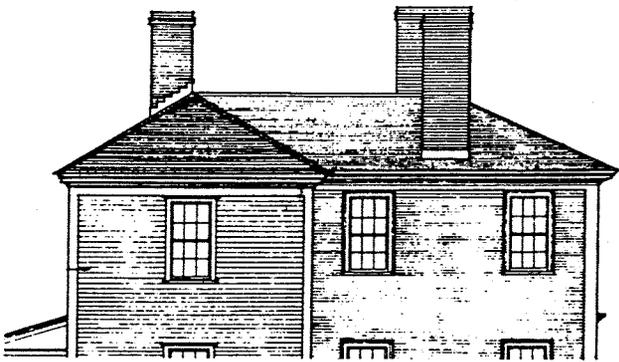
Detail, Hipped roof. John Nelson House. Lincoln, Massachusetts. 1811. (Courtesy of HABS)

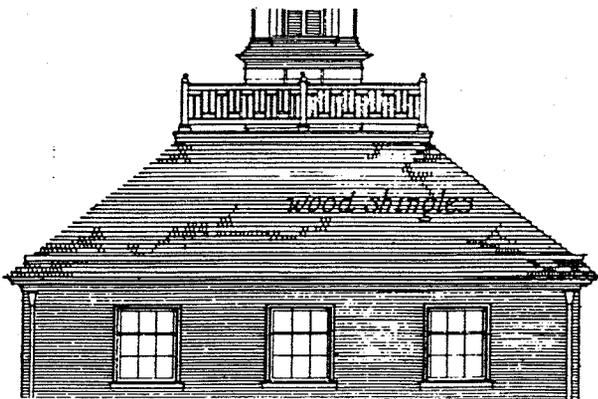
Detail, Wood shingle roof. Old Town Hall. New Castle, Delaware. 1823. (Courtesy of HABS)

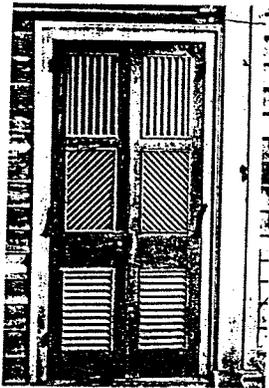
*Detail, variation of the vernacular double leaf louvered door (or "blinds"). Odessa, Delaware. Reprinted from the Early Architecture of Delaware.*

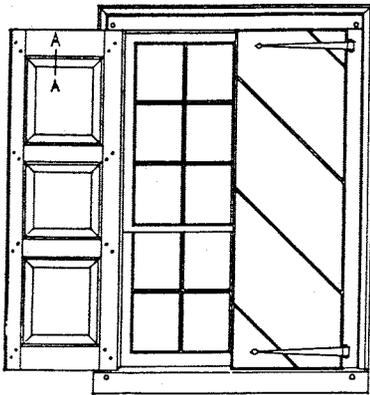
*Detail, Georgian style shutters with raised panels and strap hinges. Brown House. Peach Bottom, Pennsylvania. Reprinted from Early Domestic Architecture of Pennsylvania.*

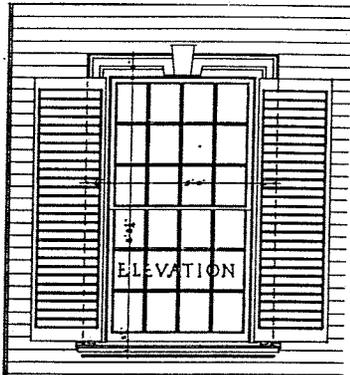
*Detail, fixed louvered (Venetian) shutters with raised panels and strap hinges. Old Manse. Suffield, Connecticut. C. 1790. Reprinted from the Architectural Treasures of Early America.*

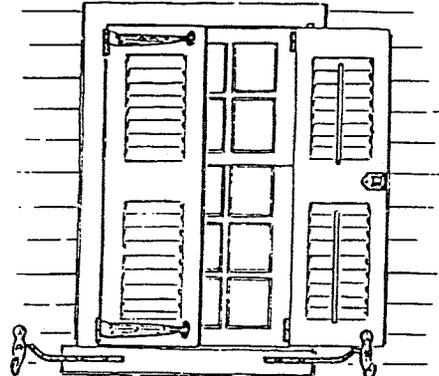
*Detail, window installed with movable louvered shutters hung with strap hinges. Courtesy of Ball and Ball, Exton, Pennsylvania. Reproductions of Antique House and Cabinet Hardware and Accessories.*

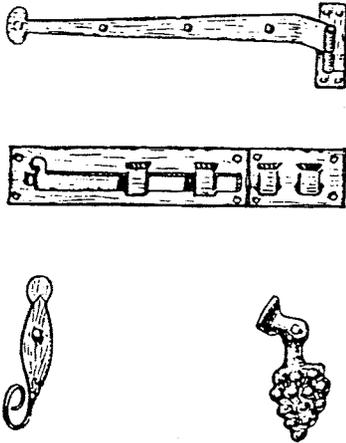
*Samples of strap hinges, shutter bolts, and decorative cast iron hold backs. Courtesy of Ball and Ball, Exton, Pennsylvania. Reproductions of Antique House and Cabinet Hardware and Accessories.*

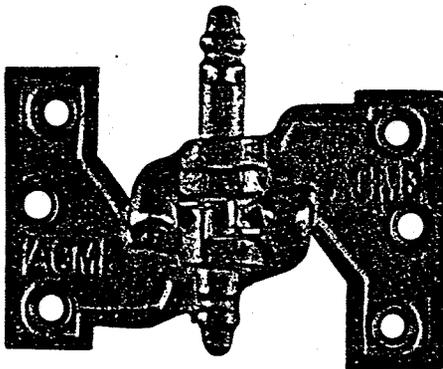
*"ACME" self-holding shutter hinge. Courtesy of Ball and Ball, Exton, Pennsylvania. Reproductions of Antique House and Cabinet Hardware and Accessories.*

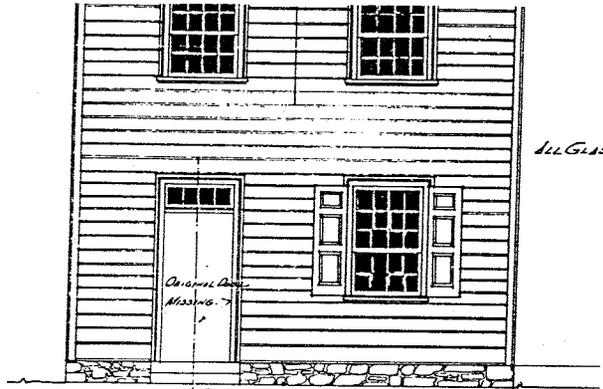
Detail, clapboard siding. "Pre-Revolutionary Period" house in Odessa, Delaware. C. 1760. Reprinted from *Early Architecture of Delaware*.

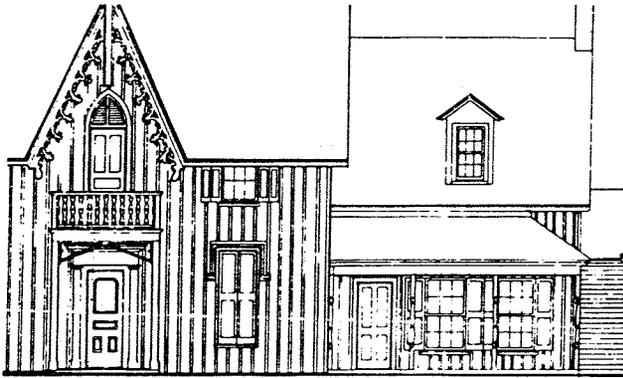
Detail, board and batten siding. A.B. Austin House. Paris, Illinois. 1854. (Courtesy of HABS)

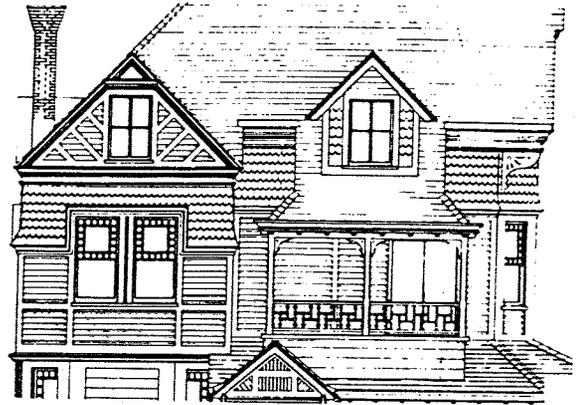
Detail, clapboards and decorative shingles. Miss Parks House. Cape May, New Jersey. C. 1876. (Courtesy of HABS)

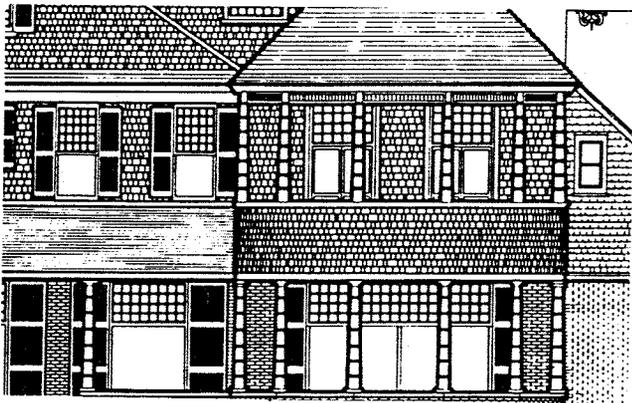
Detail, shingle siding. Isaac Bell House. Newport, Rhode Island. 1882-1883. (Courtesy of HABS)

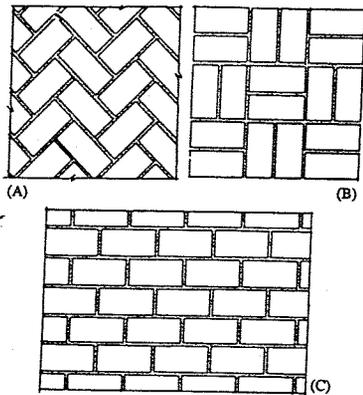
Typical brick paving patterns found in the Historic Area: (A) Herringbone, (B) Basketweave, (C) Running. Reprinted from Architectural Graphic Standards, Second Edition.

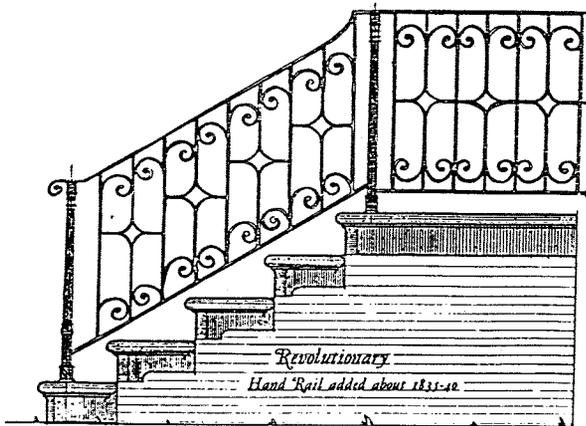
Detail, molded stone steps and wrought iron railing. Reprinted from Early Architecture of Delaware, plate no. XXX.

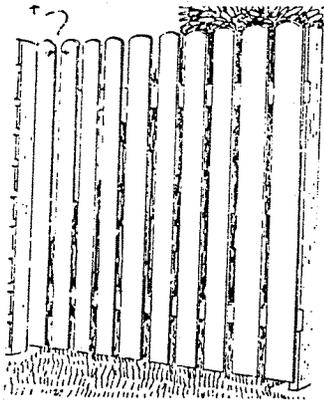
*Simply designed picket fence appropriate for most properties in the Historic Area.*

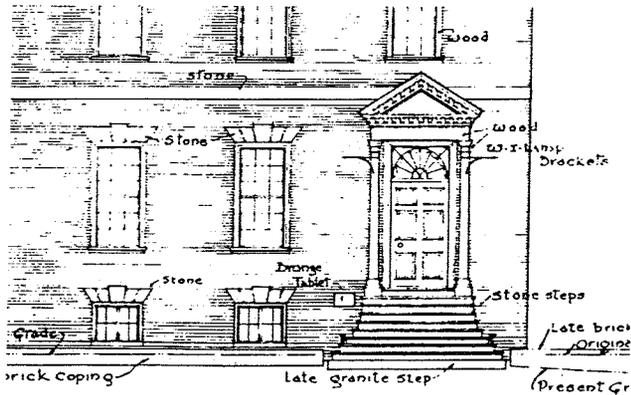
*Mid-Georgian period, portland stone steps with molded treads. Whittle House. Norfolk, Virginia. 1791. (Courtesy of HABS)*

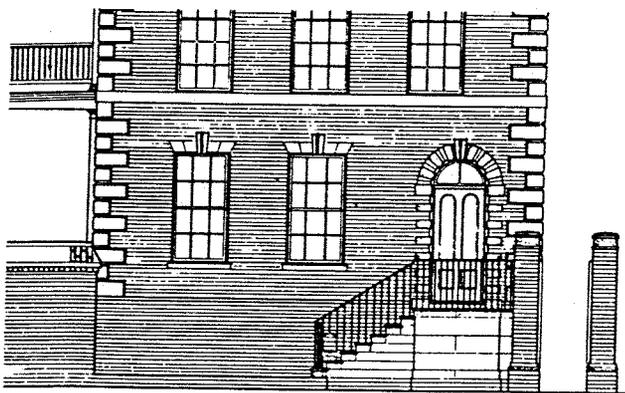
*Late Federal period, marble steps and stoop with wrought iron railing. Gadsden House. Charleston, South Carolina. C. 1800. (Courtesy of HABS)*

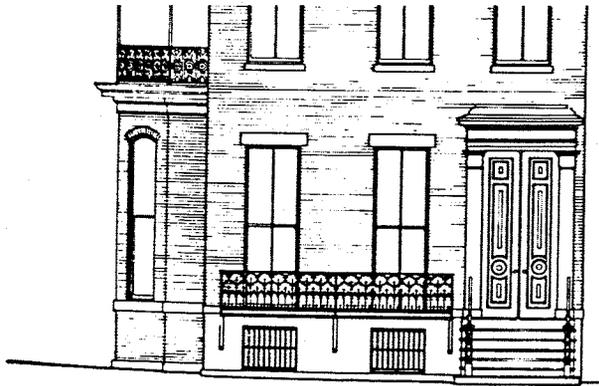
*High-style Italianate-period steps made of granite with cast iron posts and railings. Robert Campbell House. St. Louis, Missouri. C. 1855. (Courtesy of HABS)*

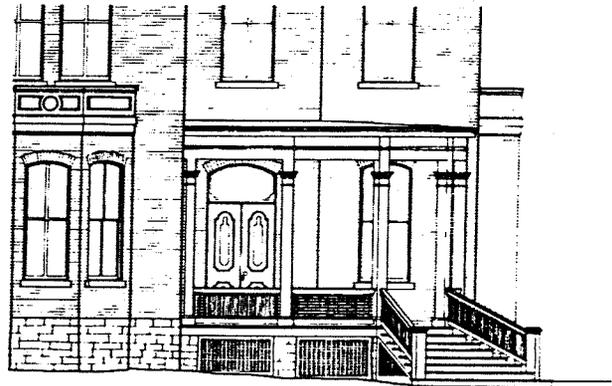
*Italianate-period wooden steps at a corner entrance. Superintendent's House, Tower Grove Park. St. Louis, Missouri. 1868-1869. (Courtesy of HABS)*

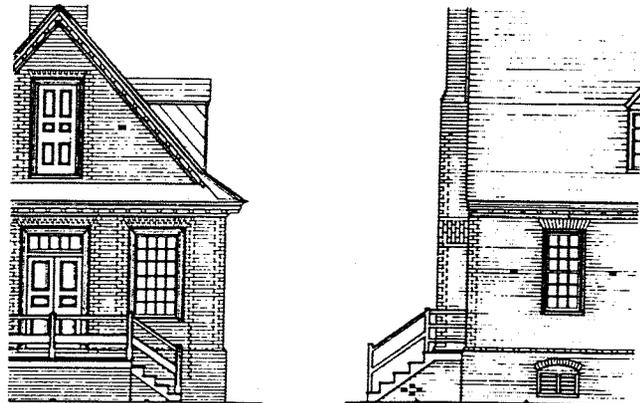
*Wood steps with brick cheeks. Prentis Store. Williamsburg, Virginia. 1740. (Courtesy of HABS)*

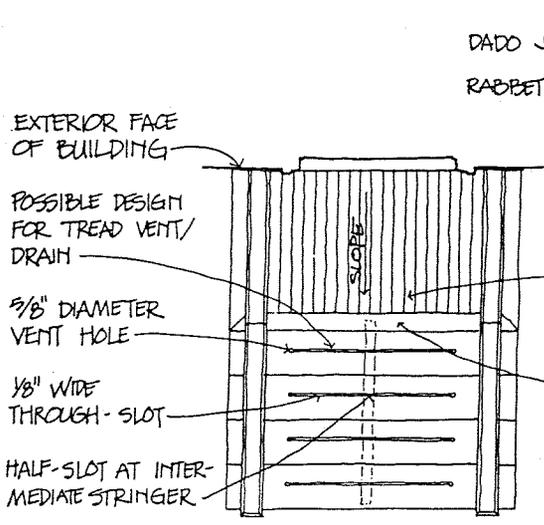
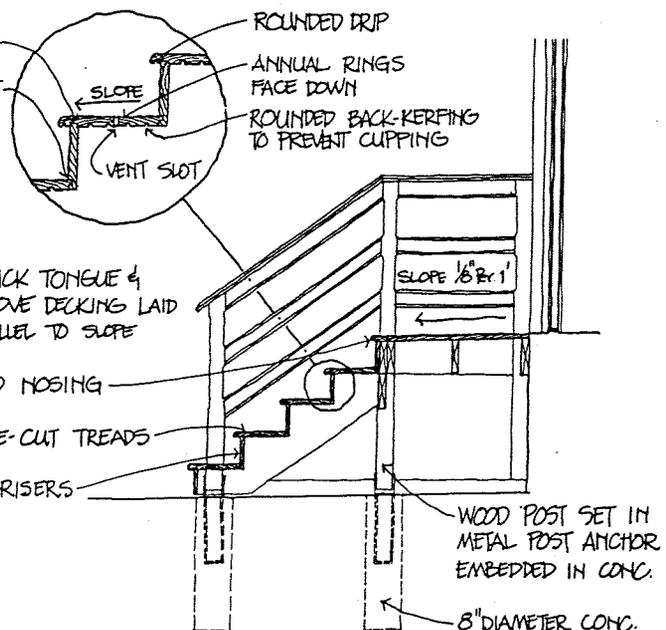
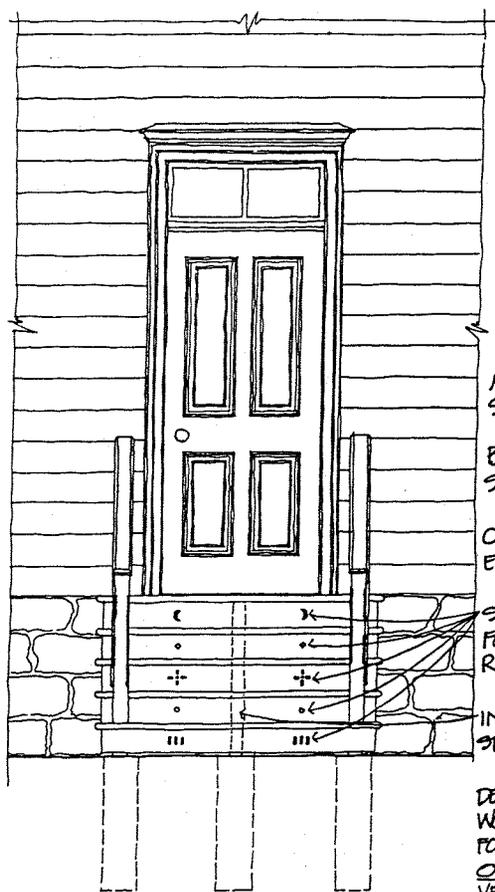
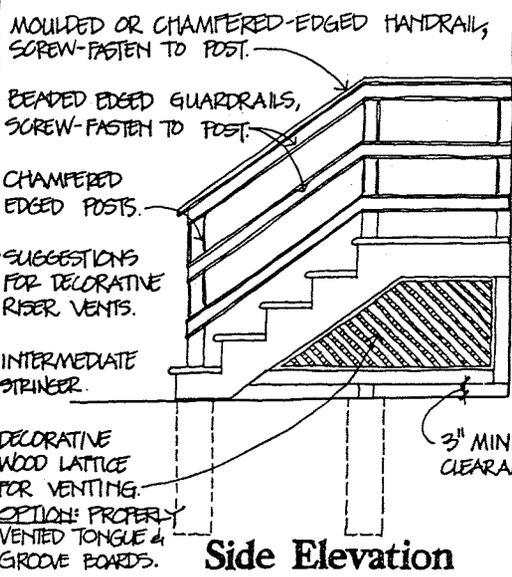
**Front Approach Stair:** RECOMMENDED FOR USE ON WIDE SIDEWALKS

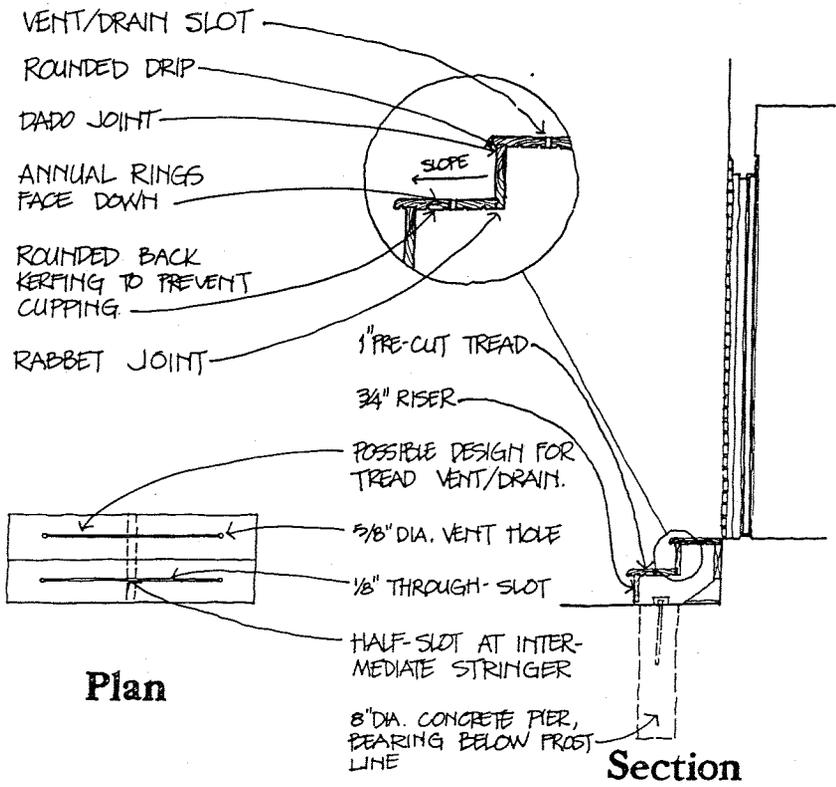
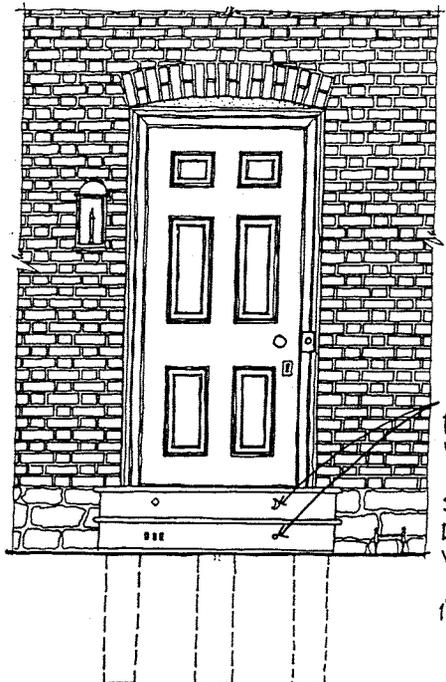
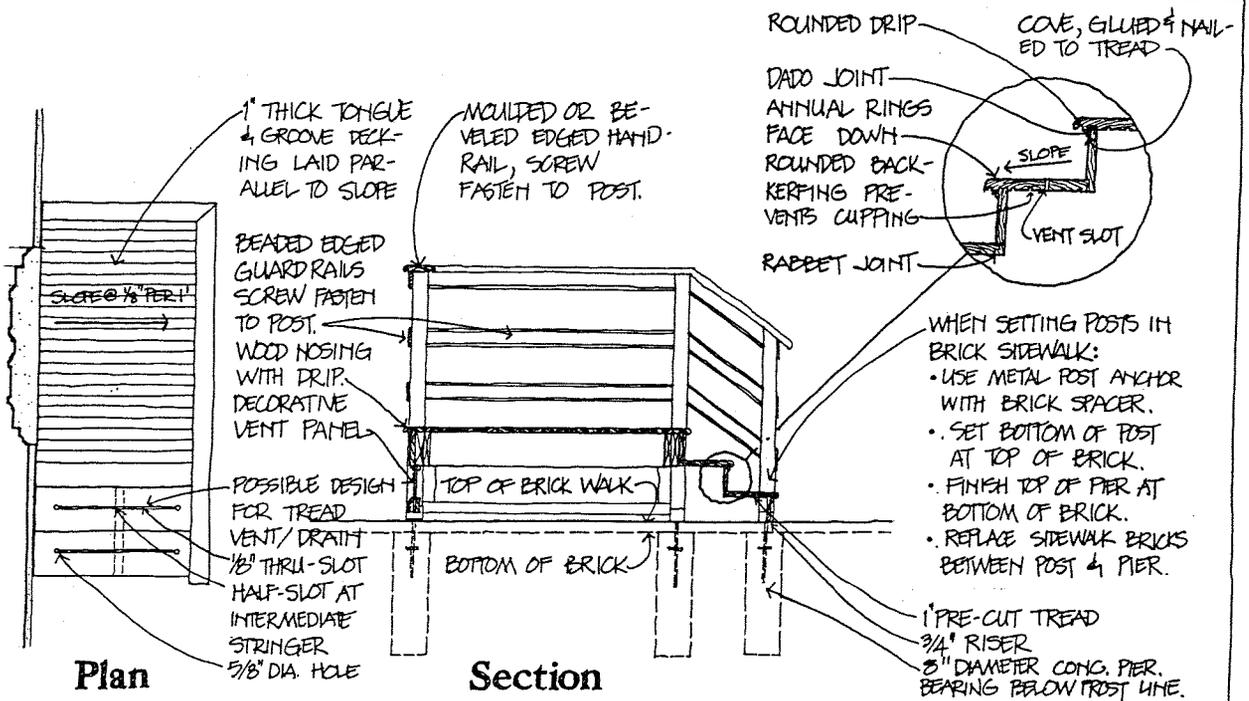
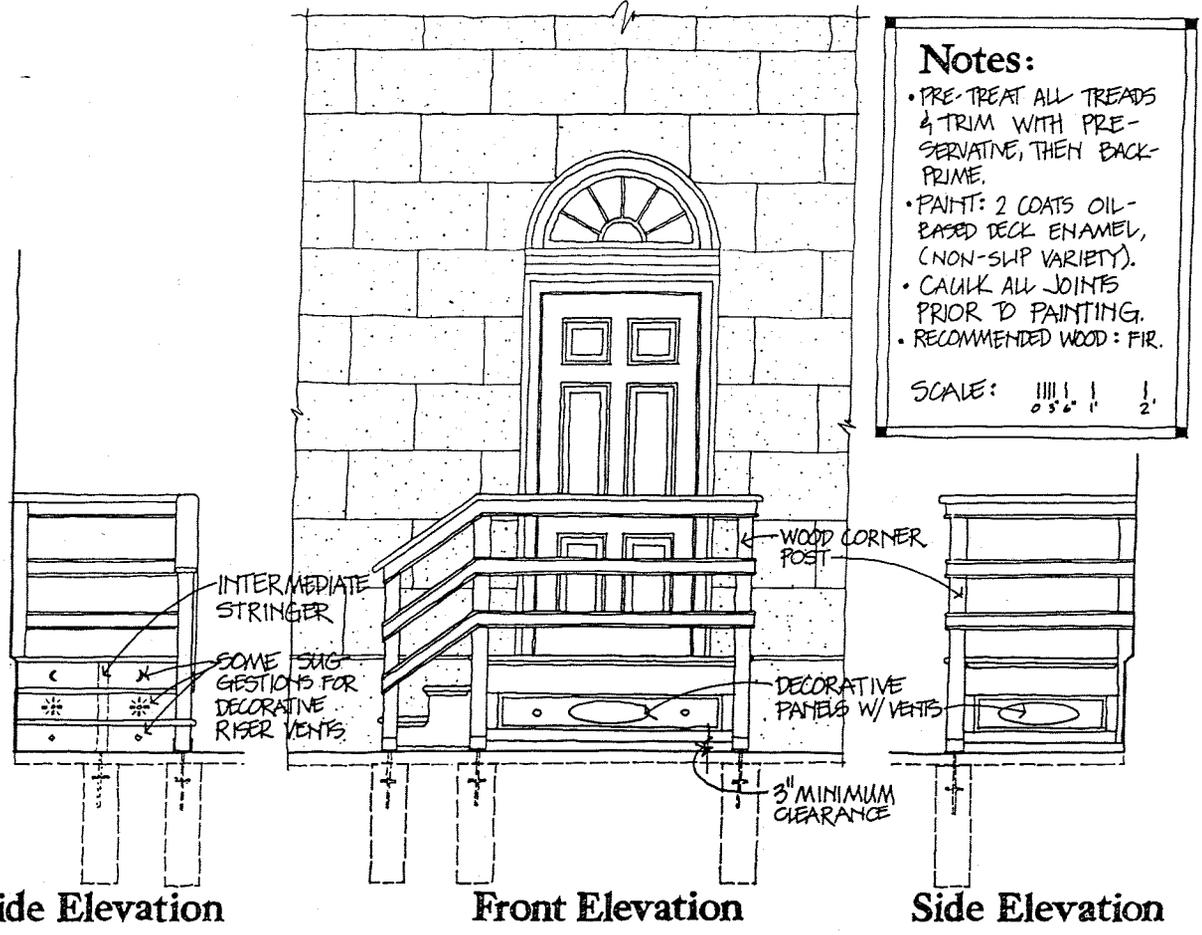
**Side Approach Stair:** RECOMMENDED FOR USE ON NARROW SIDEWALKS

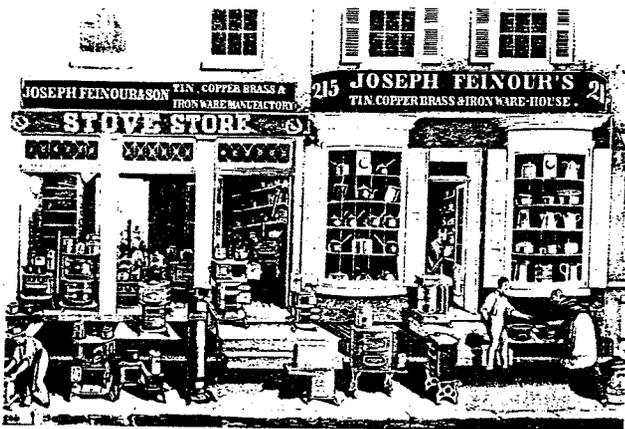
Examples of a Greek Revival Style shopfront (left) and a Federal Style shopfront (right). Joseph Feinour's Stove and Hardware Stores, Front Street south of Spruce, lithograph by Wagner & McGuigan after W.H. Rease, ca.1845. (Courtesy of the Library Company of Philadelphia)

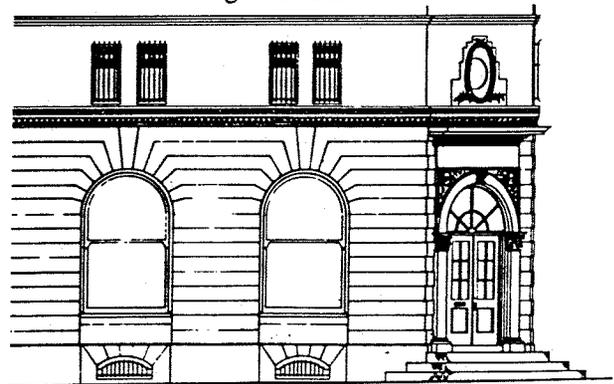
*Commercial Georgian Revival design. Detail: New Jersey Trust and Safe Deposit Company. Cape May, New Jersey. 1895. (Courtesy of HABS)*

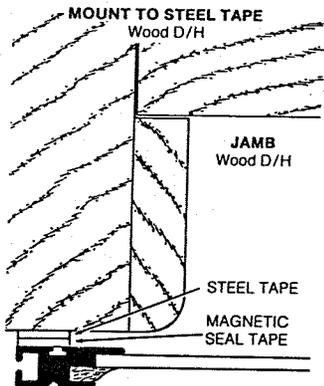
*Interior magnetically-mounted storm sash. The Magnetic One Lite (MOL). Reprinted from Allied Window Inc. catalog. Cincinnati, Ohio.*

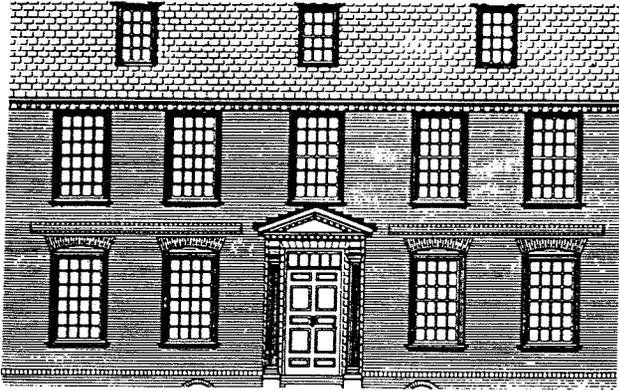
Mid-Georgian period, twelve-over-twelve double hung sash. Derby House. Salem, Massachusetts. 1752. (Courtesy of HABS)

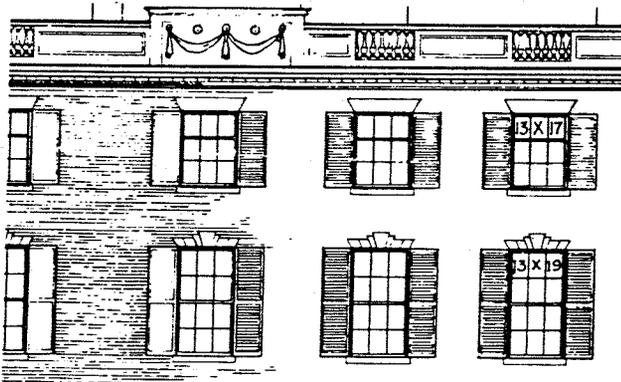
Federal period, six-over-six double hung sash. Armory Ticknor House. Boston, Massachusetts. 1804. (Courtesy of HABS)

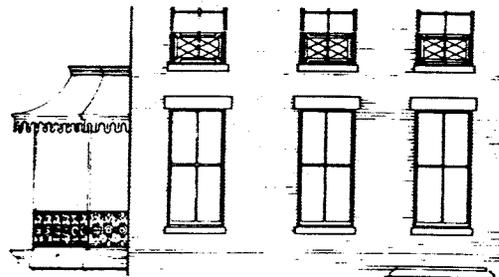
Early Italianate period, two-over-two double hung sash. Robert Campbell House. St. Louis, Missouri. C.1855. (Courtesy of HABS)

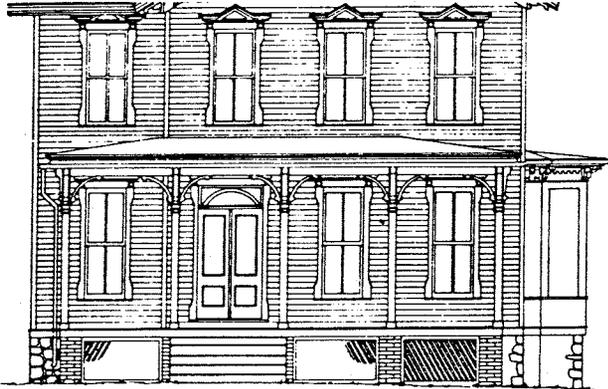
*Late Italianate period, two-over-two double hung sash. Morrow House. Lawrence, Kansas. 1870-1875. (Courtesy of HABS)*

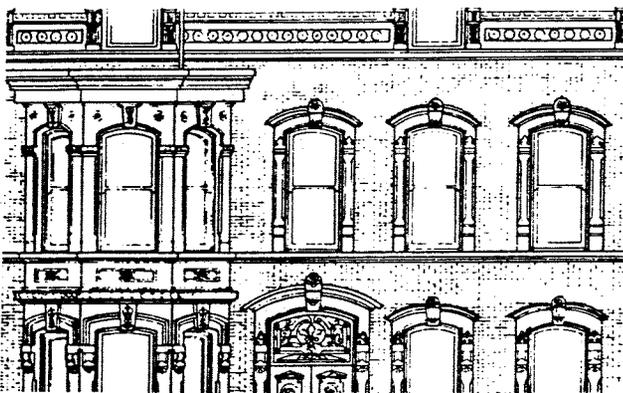
*Second Empire period, one-over-one double hung sash. John DeKoven House. Chicago, Illinois. 1874. (Courtesy of HABS)*

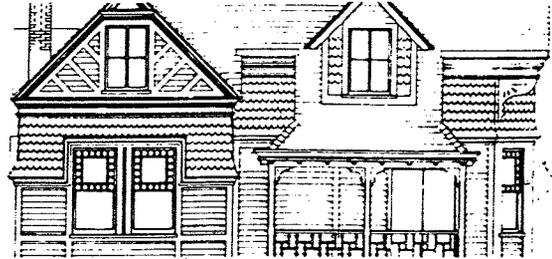
*Queen Anne period, one-over-one double hung sash. Miss Parks House. Cape May, New Jersey. C.1876. (Courtesy of HABS)*

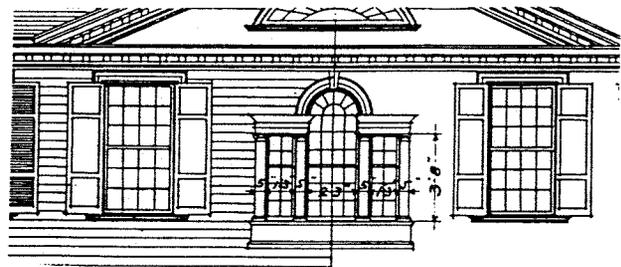
*Palladian window. The Field House. Longmeadow, Massachusetts. Reprinted from Architectural Treasures of Early America.*
